Effectiveness of Radar Speed Feedback Signs & Other Traffic Calming Techniques: A Test Case in Shelburne, Vermont: 2006-2012

Final Draft: 16 September 2013

Addison County Regional Planning Commission 14 Seminar Street Middlebury, Vermont 05753

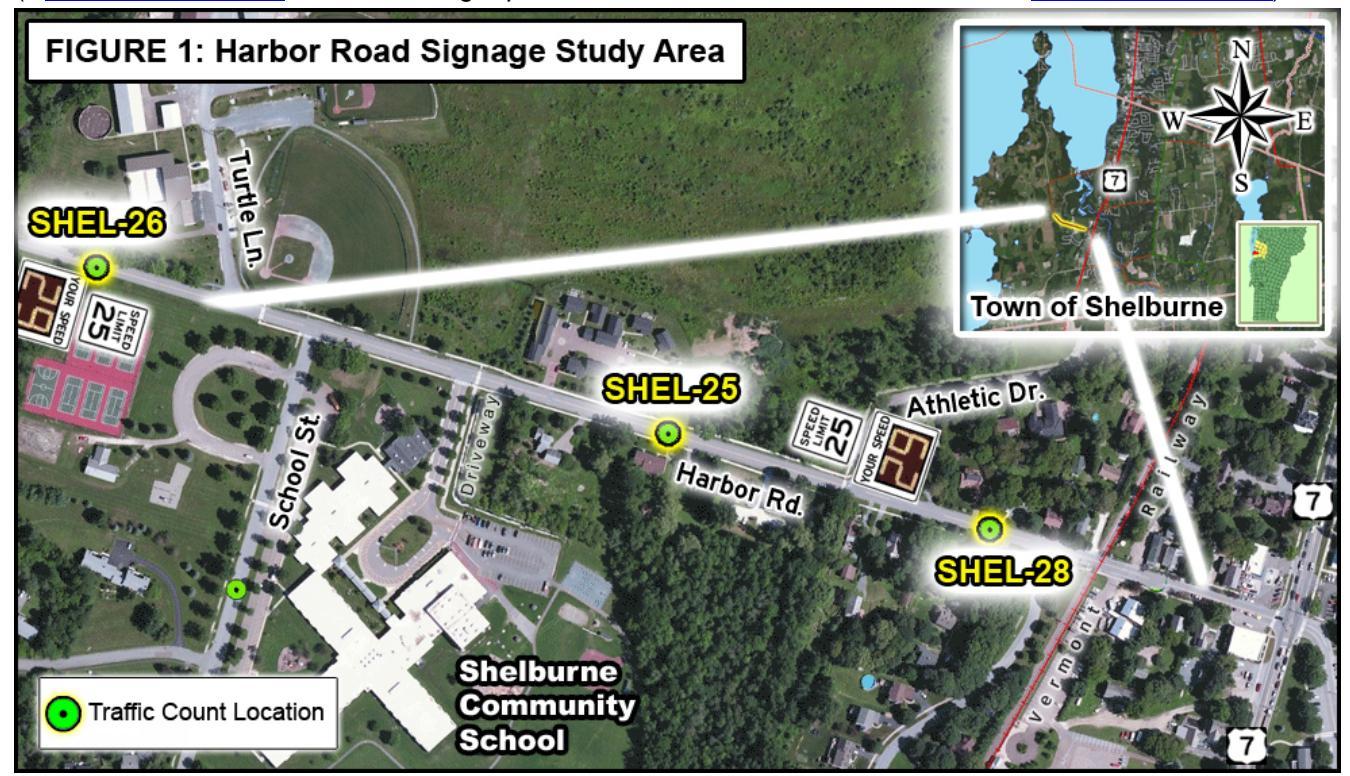
ACRPC tested the change in 85th Percentile Speed of two radar speed feedback signs at three locations along Harbor Rd. in Shelburne (see **Figure 1**), using ATR data, which was collected before and after the signs were installed in 2012 (a <u>time-series animation</u> of traffic calming implementation on Harbor Road from 2006-2012 is available at this link).

ATRs were set up in 2006, 2010 and 2012 at the signpost west of the Turtle Lane intersection on Harbor Road (see **Figure 1**). This location is also where a new radar speed feedback sign was installed to replace the 25 mph posted speed limit sign in 2012. This is the exact position where each ATR count occurred in for all three time periods. **Table 1a** indicates the changes in measured 85th percentile speed captured between 2006-2012.

ATRs were set up in 2006, 2010 & 2012 at GMPC Pole #12 between Athletic Drive and the Shelburne Community School on Harbor Road (see **Figure 1**). This is the exact position each ATR was installed during all three data collection periods. **Table 2a** shows the primary speed reduction occurred between the 2010 and 2012 period.

The cause of this "effect" is unclear from a review of published literature. It may be possible that since most of the traffic within the study area originated from either end of Harbor Rd. (and not School St. – see **Figure 1**) where it passed view of a feedback sign readout, that a slower traffic speed was therefore established. Drivers may have then chosen to maintain their slower speed because they perceived the internal school zone characteristics (e.g. MUTCD-compliant fluorescent signage, bump-outs, crosswalks, etc.). It is also possible that the slower speed of oncoming traffic may have simply influenced drivers to reduce their speed.

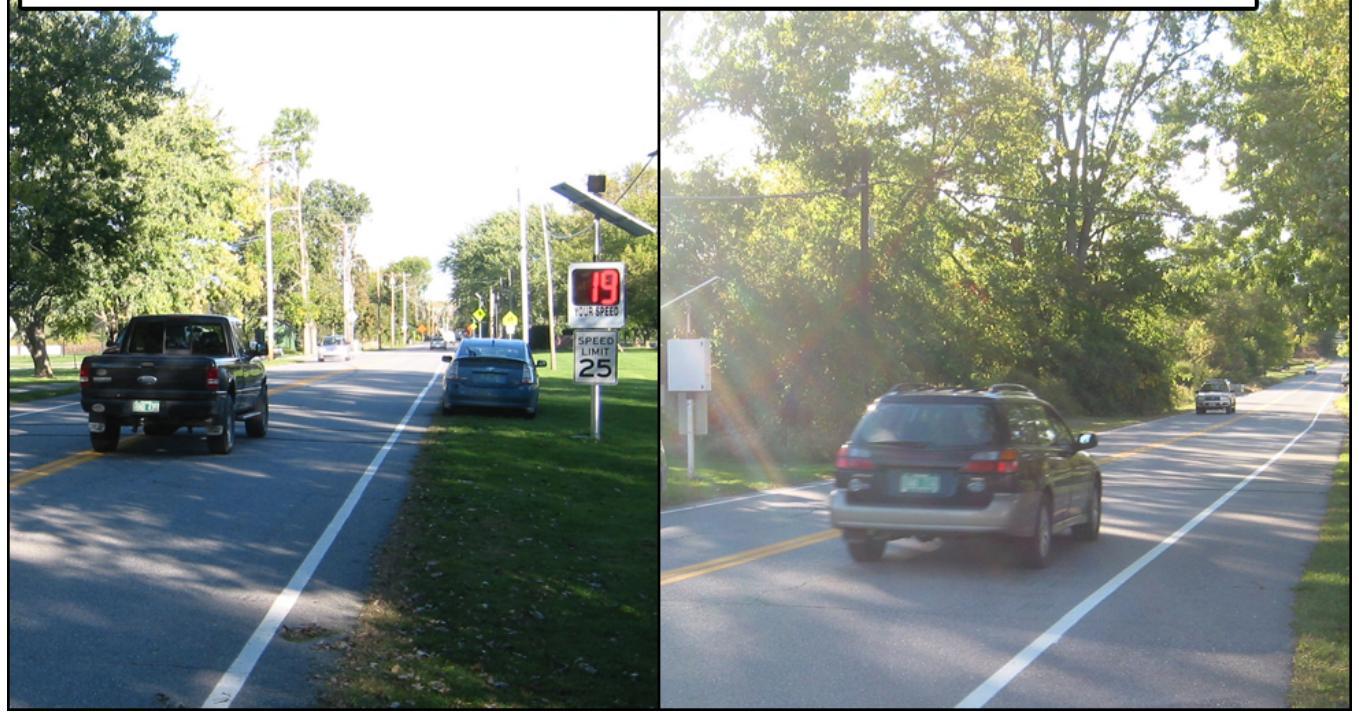
FIGURE 2: Harbor Road (SHEL-26) Eastbound (left) / Westbound (right), 2012

Figure 2 illustrates the transition zone along Harbor Rd. where eastbound traffic (left) transitions from a 35 mph posted speed limit to 25 mph with a clear view of the sign's readout. The westbound traffic (right) does not face the readout.

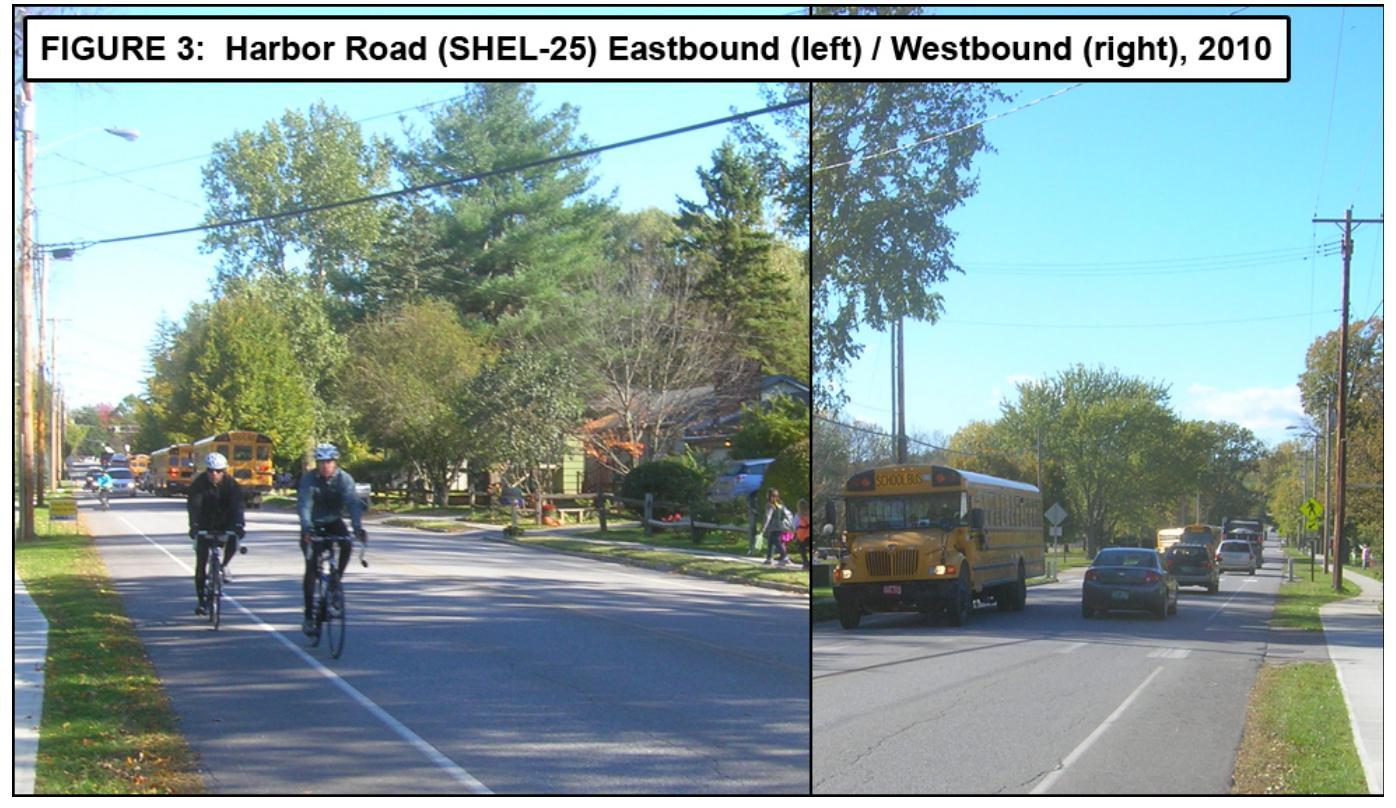
Figure 3 illustrates the school zone traffic just after school had been dismissed for the afternoon. Although pedestrians had been observed to consistently use the sidewalks (left), there were also a high number of bicyclists and school busses sharing the road, which ensured low traffic speeds during this time-period. The 2006-2012 ATR installations were setup on the 1st telephone pole shown in the eastbound view of **Figure 3**, and in the westbound view in **Figure 4**,

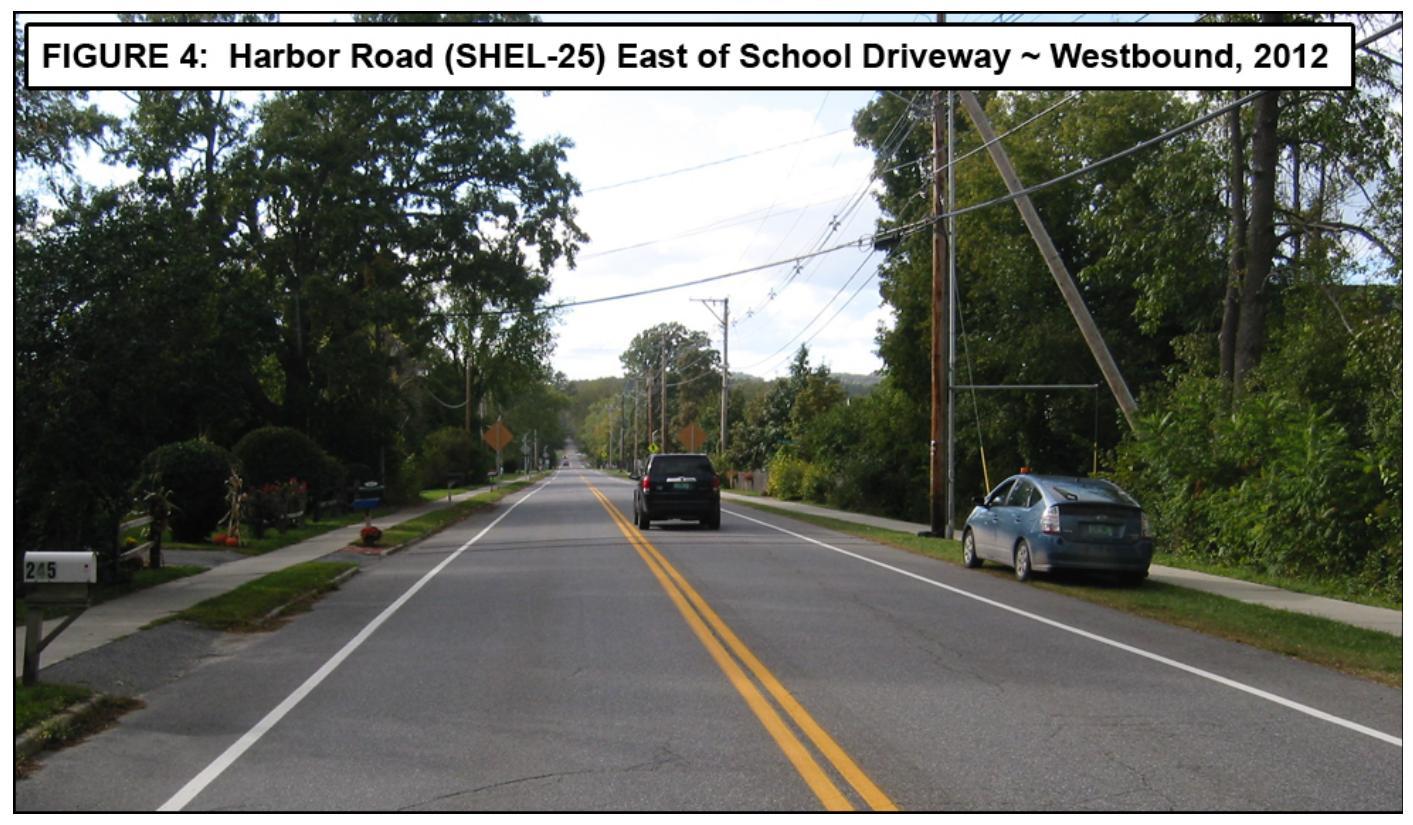
which also shows the ATR setup capturing a westbound vehicle's speed after passing view of the radar sign's readout.

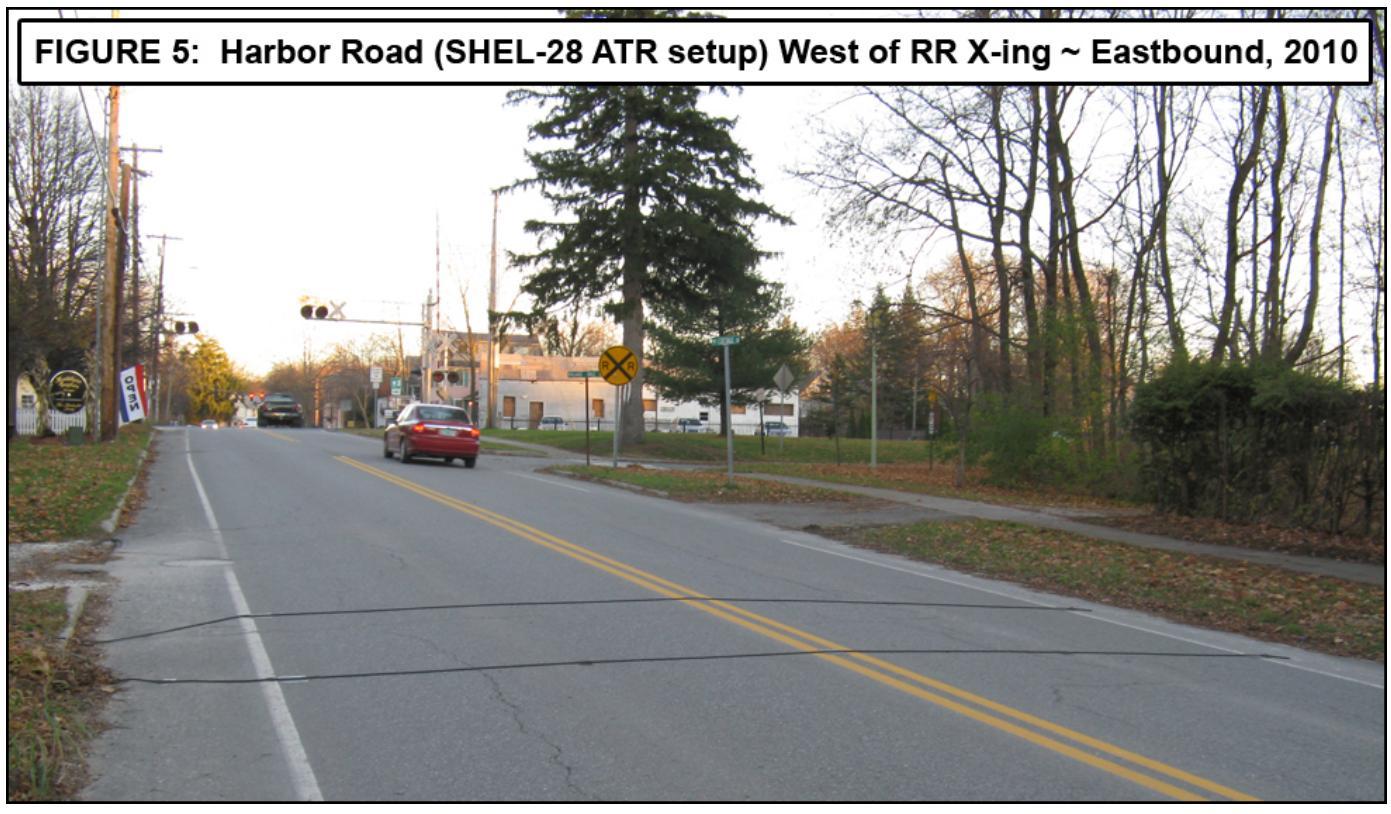
ATRs were setup in 2010 and 2012 at GMPC Pole #6 between Athletic Drive and the Railroad crossing on Harbor Road, about 350 ft. east of where the radar feedback sign was eventually installed in 2012 (see **Figure 5**). This is the exact position where each of the ATRs were installed for both count periods.

The new sidewalk was installed from Athletic Drive to a location near the railroad crossing to the east of this location (see **Figure 5**). It is inconclusive whether the presence of the sidewalk had any effect on driver perception, and hence the speed of traffic. Nevertheless, the radar feedback sign may be seen roughly 340 ft. ahead of this position (circled area within **Figure 6**). Although it may not seem evident from the view in **Figure 6**, vehicle speed feedback is clearly observable to drivers from this location. **Figure 7** shows a closer view of the sign and pedestrian crossing ahead.

Table 3a indicates an observed 85th percentile speed reduction of 3 mph for each direction of travel between 2010 and 2012 (captured at the location shown in **Figure 5** and **Figure 6**).

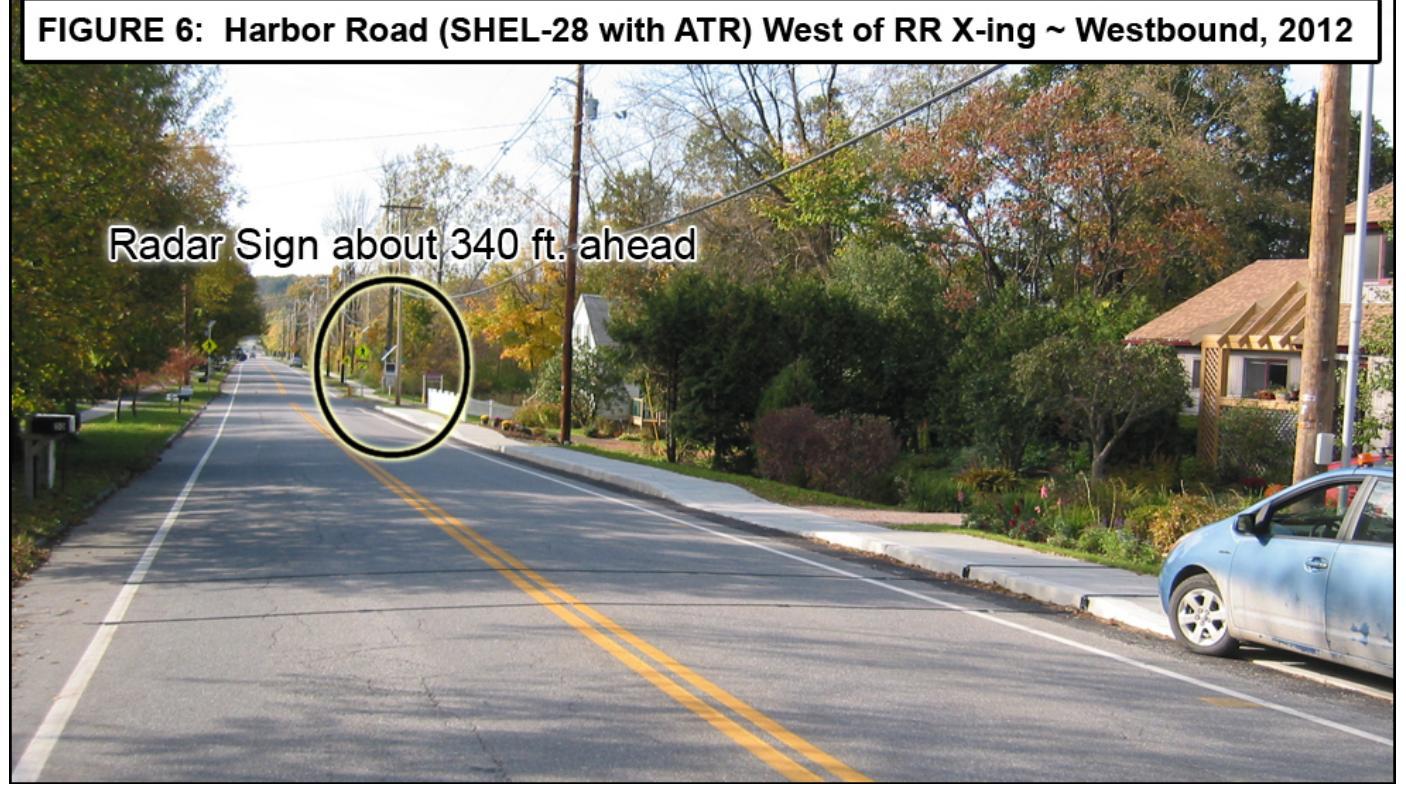
Figure 6 is a westbound view of this location where it is observable that a sidewalk had been constructed along the northern side of Harbor Rd. (right) between 2010 and 2012.
